MEGII実験液体キセノン検出器で用いられる 光検出器の実機環境における応答の評価

Kohei Shimada On behalf of MEG II collaboration The University of Tokyo

Sep. 15th, 2020

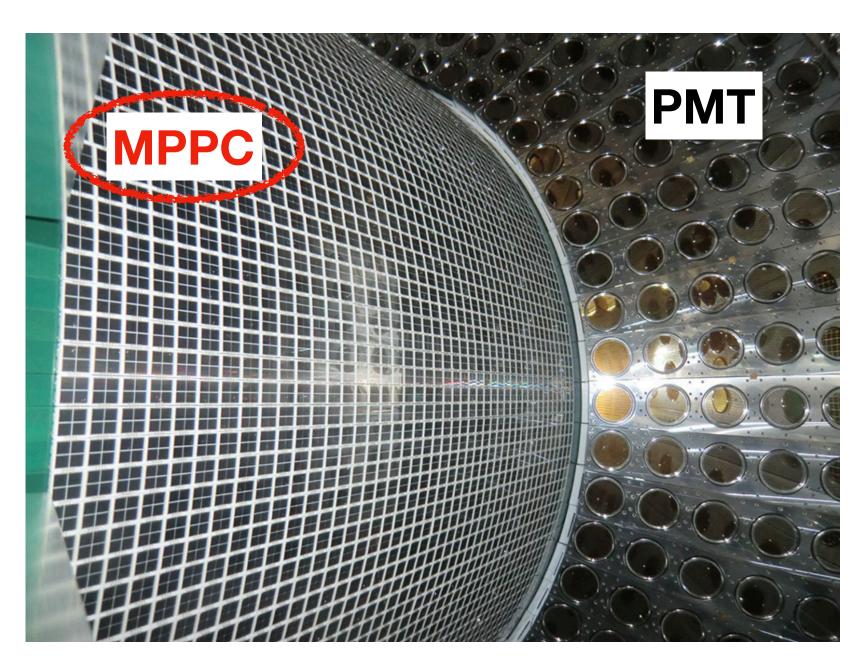
Overview of the MEG II experiment at Paul Scherrer Institut

- Detect the scintillation ($\lambda = 175$ nm)
- · 4092 MPPCs, 668PMTs at 160K~165K
- Energy and position resolutions will be improved as compared with MEG by a factor of two
- Under commissioning since 2017

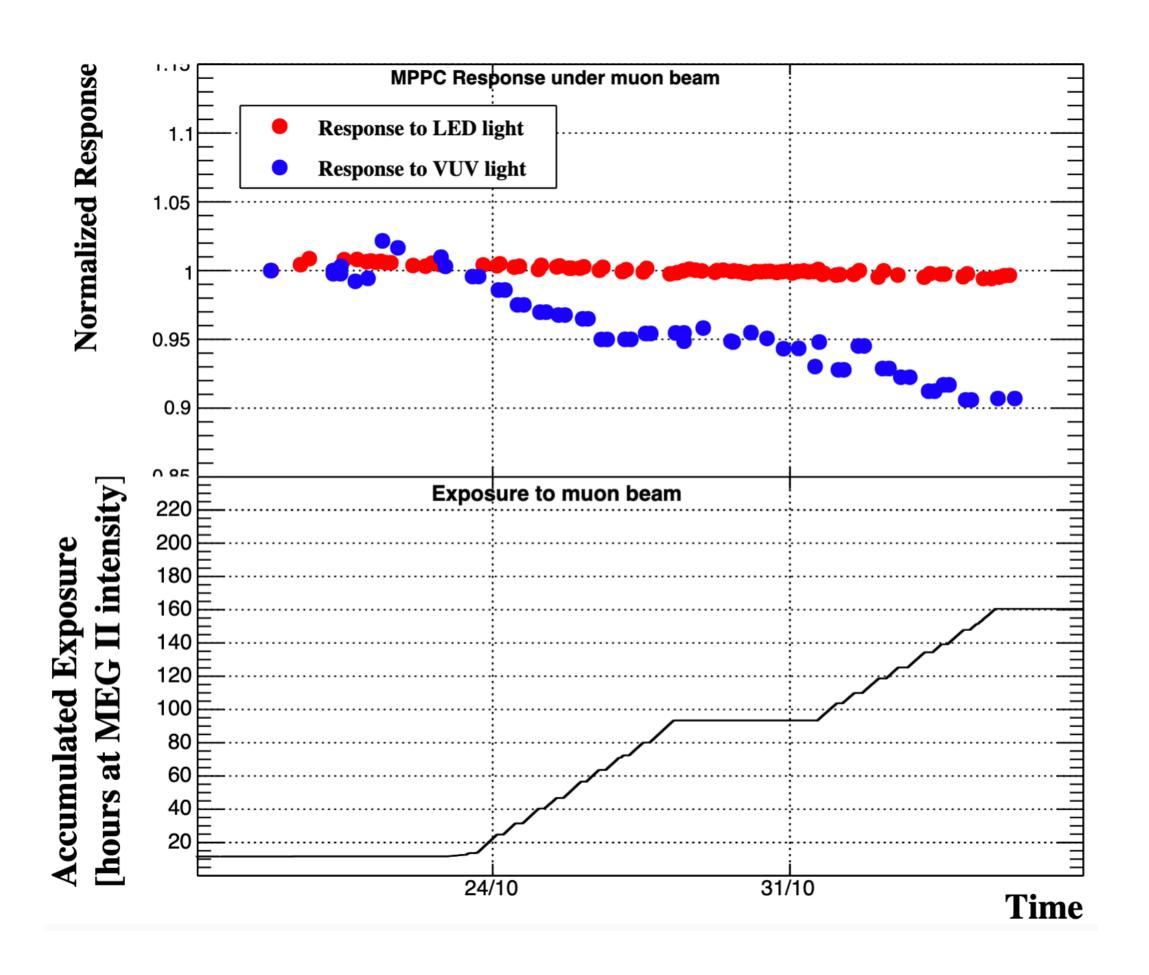
VUV-sensitive MPPC PDE decrease

- · Degradation of MPPC VUV-sensitivity →quite fast ~0.05%/hour (under MEG II beam intensity $7 \times 10^7 \mu$ /sec)
- MEG II DAQ time (design) : 140 days/year, 3 years
 →This degradation is a serious problem
- A possible cause: Gamma, Neutron irradiation
 →In lab test, no effect on PDE was observed

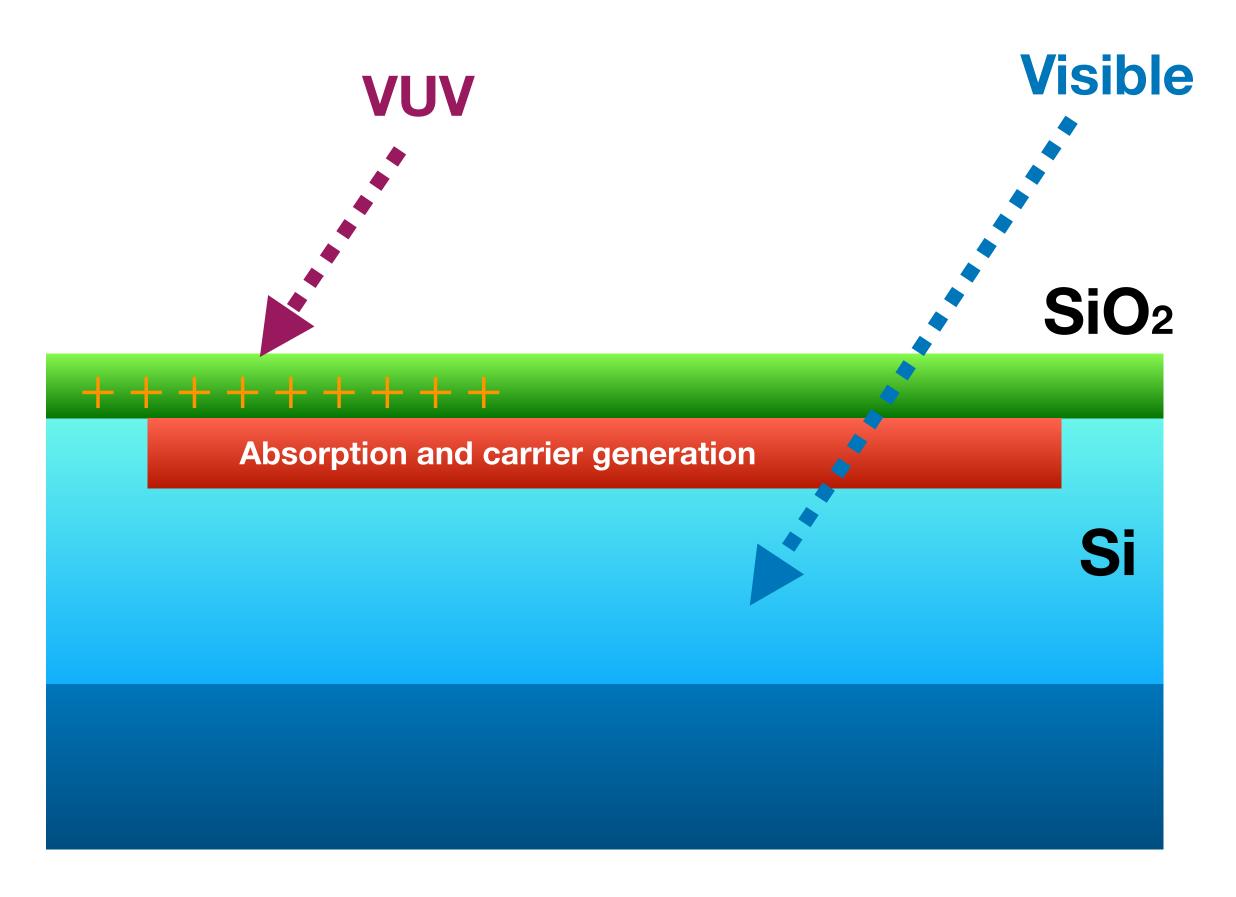
- Electron-holes are generated in SiO2 by VUV light
- · Holes are trapped at interface SiO₂-Si
- The electric field near the boundary of the two surfaces will be reduced by the holes
 →Collection efficiency will be reduced
- Degradation may be accelerated at low temperature
 →Holes hardly move
 - \rightarrow Anealing is one of solutions

Possible cause : surface damage by VUV light

- Electron-holes are generated in SiO2 by VUV light
- Holes are trapped at interface SiO₂-Si
- \rightarrow Collection efficiency will be reduced
- Degradation may be accelerated at low temperature)
 - \rightarrow Holes hardly move
 - \rightarrow Anealing is one of solutions

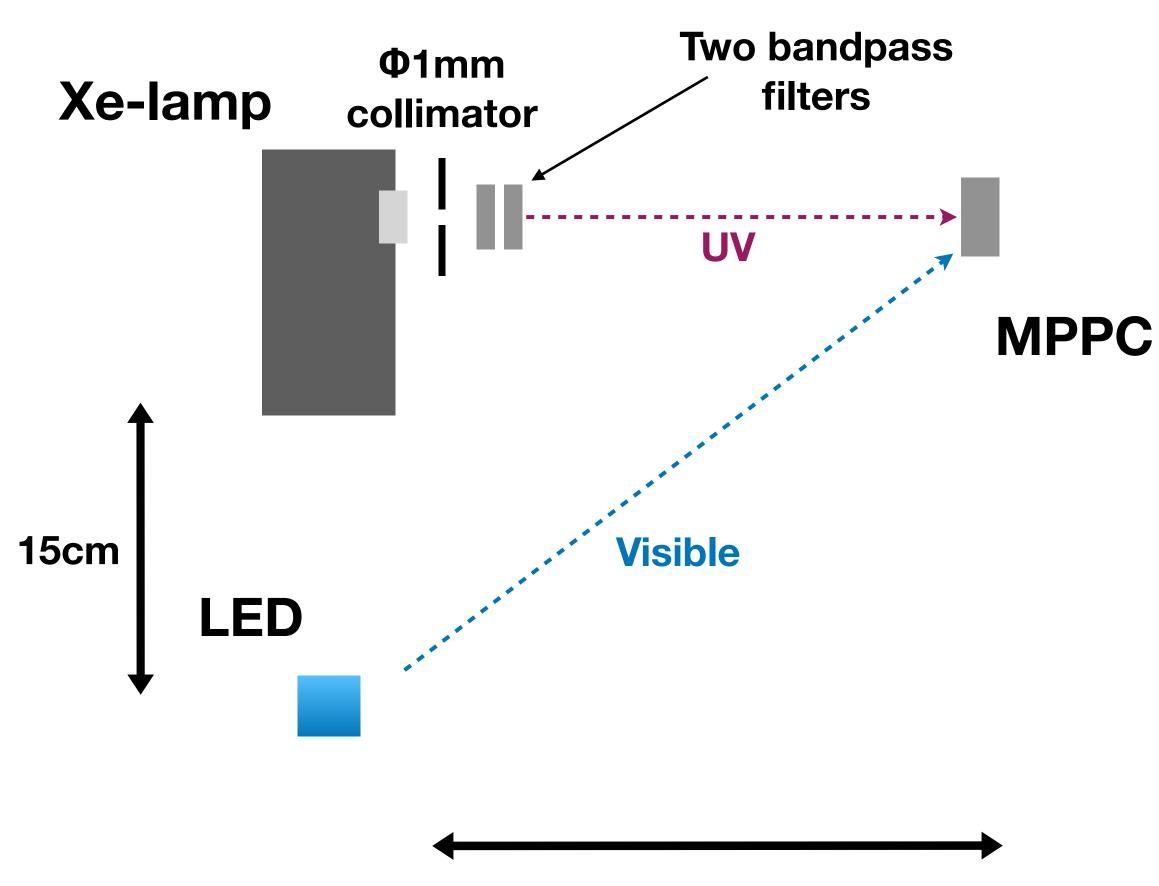
Setup for charge measurement

- Charge was measured by oscilloscope to observe PDE decrease
- Irradiate MPPC by Xe-lamp w/ filter and PDE for UV was observed
 UV : 185nm~400nm
- Irradiate MPPC by LED w/o filter and PDE for visible was observed
 visible : ~450nm
 - · 4 chips of VUV-MPPC was used
 - Two MPPCs are used separately room/low temp
 - Non irradiated MPPC
 was also used
 as a reference

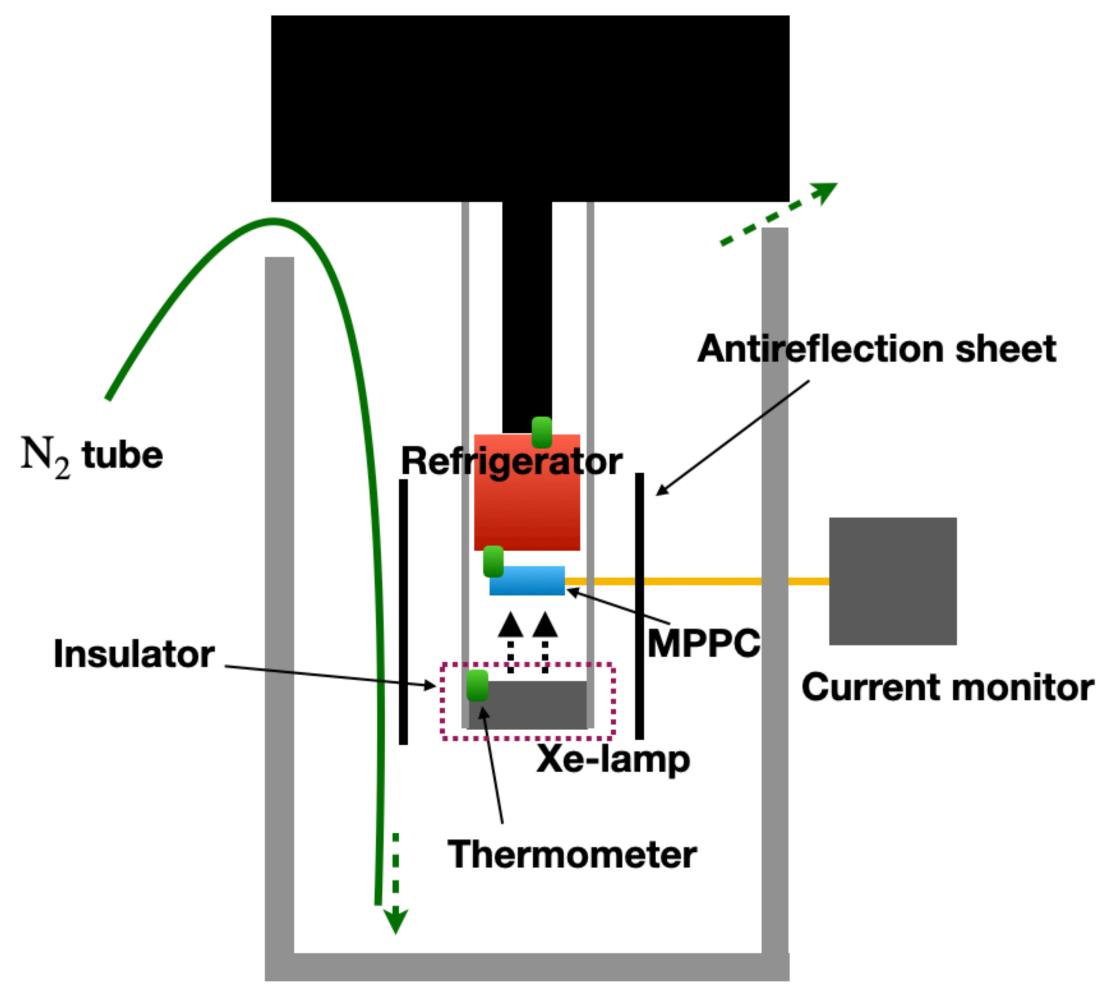
Setup for irradiation

- MPPC is mounted on pulse tube refrigerator
- \cdot Xe-lamp is fixed in Dewar
 - Irradiate MPPC directly
 - \cdot 3cm away from the lamp window
 - →total dose level of UV will reach 2019run in ~10sec
- \cdot Make N_2 flow
 - Prevent dew formation
- · 2ch current monitor
 - MPPC's response to irradiation light was monitored w/o HV

- \cdot Basically the same as Low temp
- Prevent Xe-lamp temp rising

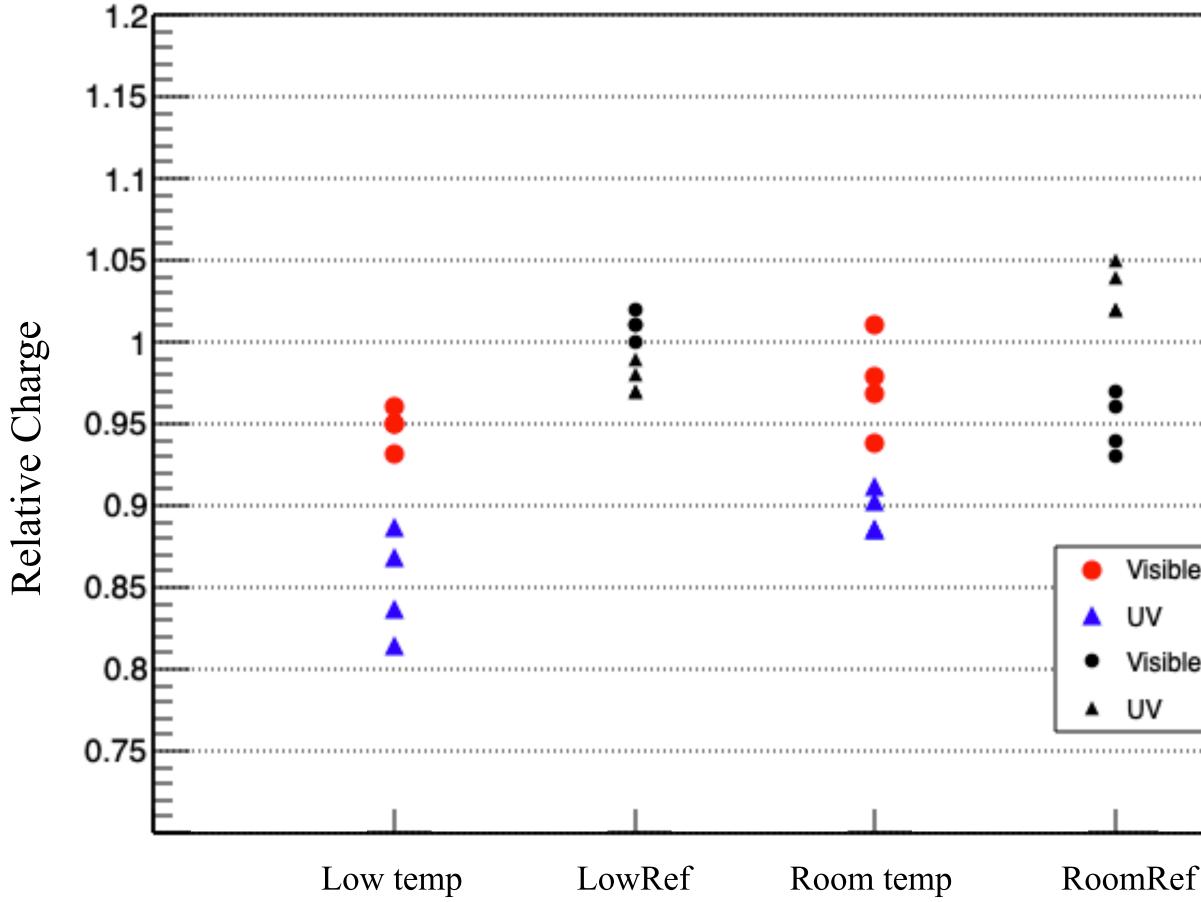
Result

UV PDE decrease at low temp was larger than at room temp

- Low : 14.8%
- **Room : 10.4%**

• At low temp, UV PDE decrease was larger than visible

- · UV : 14.8%
- Visible : 5.2%

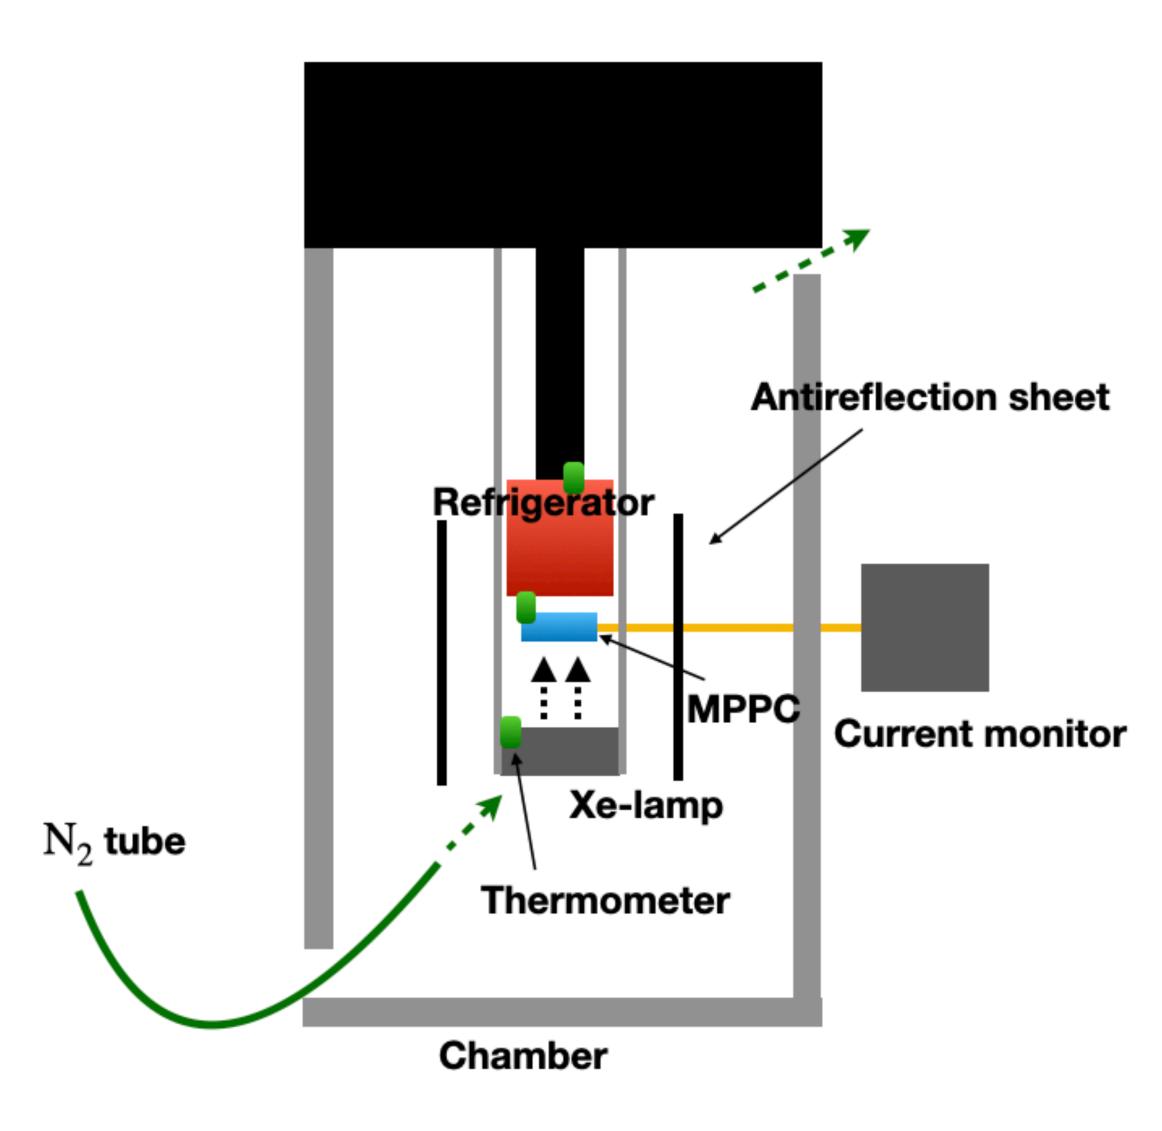
Setup for irradiation at room temp

- MPPC is mounted on refrigerator
 - refrigerator not running
- \cdot Make N_2 flow
 - \cdot make the same condition as at low temp
- · 2ch current monitor
- $\cdot \ N_2$ gas hit Xe-lamp directly
- · Dewar \rightarrow Chamber
 - prevent temperature of Xe-lamp increase

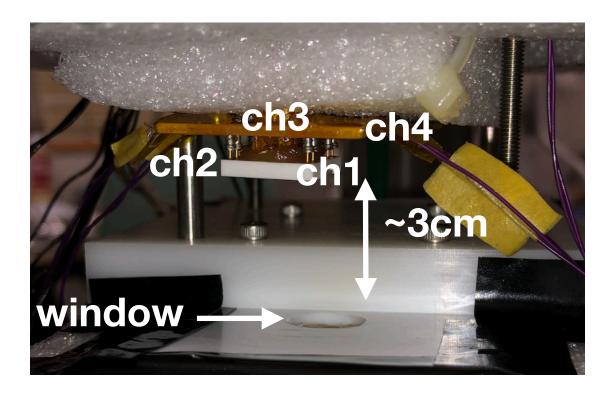
Result at low temp

- Current[µ A] 6 5.8 5.6 5.4 5.2 0h 12h 24h Time
- Current decrease was observed during 24h irradiation Probably represents the PDE decrease
- Temp (~160K) is stable
 - PDE decrease for UV is larger than visible
 - PDE decrease of the channels in front of Xe-lamp window (ch1,4) are larger than other two channels(ch2,3)
 - Charge measurement results are as written below

irradiated	Visible	UV
ch1	0.95	0.79
ch2	0.97	0.86
ch3	0.95	0.86
ch4	0.96	0.82

(Normalized with charge before irradiation)

non-irradiated	Visible	UV
ch1	1.02	0.97
ch2	1.01	0.99
ch3	1.00	0.97
ch4	1.01	0.98

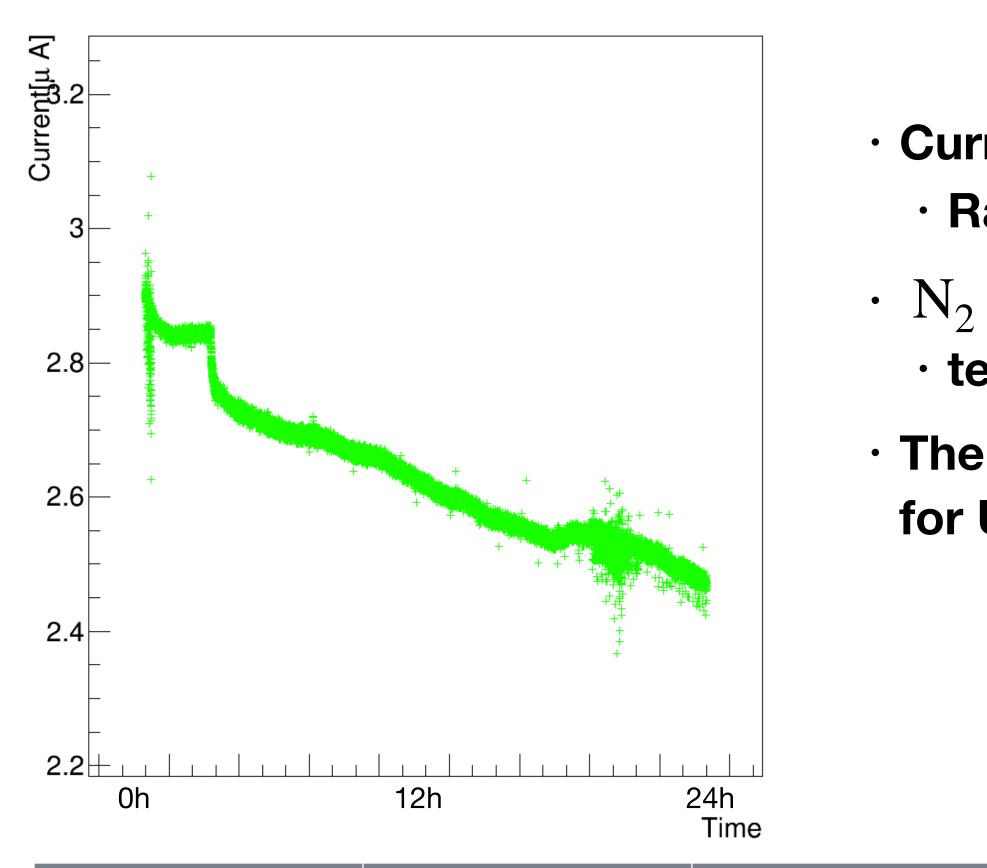
Result

irradiated	Visible	UV
ch1	0.91	0.93
ch2	0.92	0.92
ch3	0.94	0.93
ch4	0.93	0.92

Current decrease was observed during 24h irradiation Rate of decrease is lager than at low temp

- N₂ flow rate change affected current decrease rate
 temperature changed
- There was no significant difference b/w PDE decrease for UV and visible

non-irradiated	Visible	UV
ch1	0.97	1.02
ch2	0.94	1.04
ch3	0.93	1.05
ch4	0.96	1.02

(Normalized with charge before irradiation)

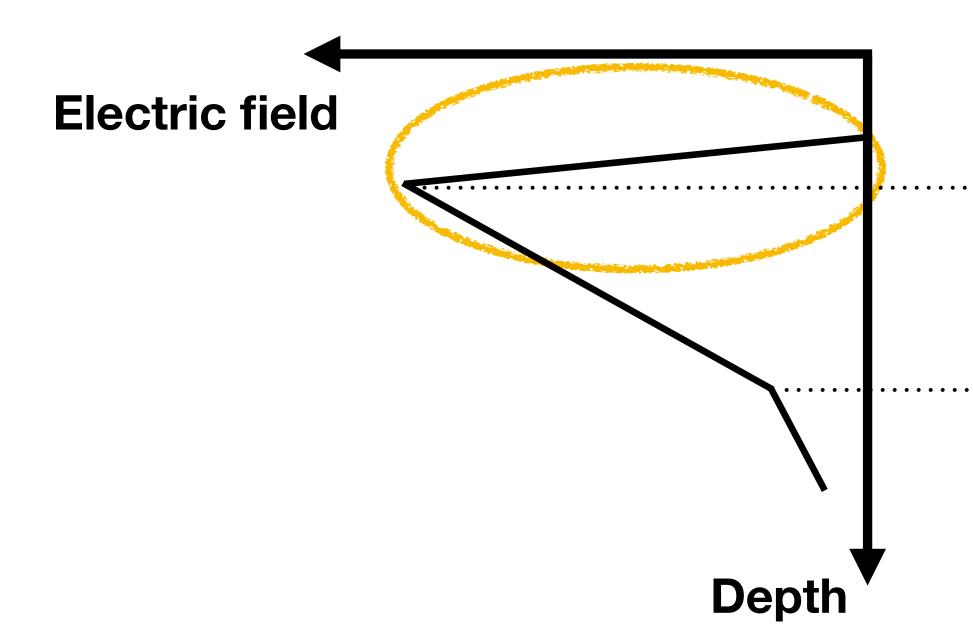
• The electric field near the boundary of the two surfaces will be reduced by the holes
