MEG II実験背景事象抑制のための DLC-RPC の長期安定性の評価

鈴木 大夢(神戸大理)

日本物理学会第79回年次大会

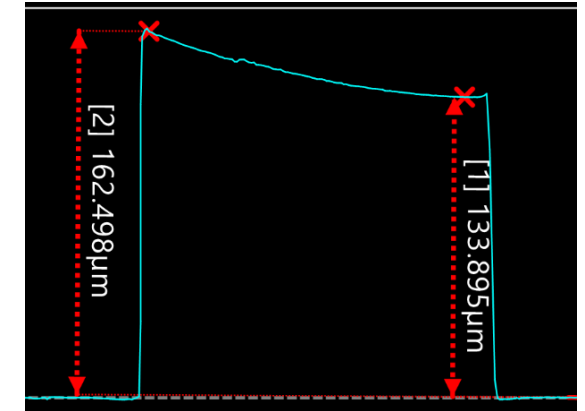
Distorted spacing pillar

- Inhomogeneous pillars that made the non-uniform gap
- Fixing method that causes the thin-film electrode to be distorted
