# MEG II 実験液体キセノン検出器の 2024年ランの運転状況

**(The status of MEG II liquid xenon detector in 2024 run)**

Ryusei Umakoshi,  
On behalf of the MEG II collaboration,  
The University of Tokyo

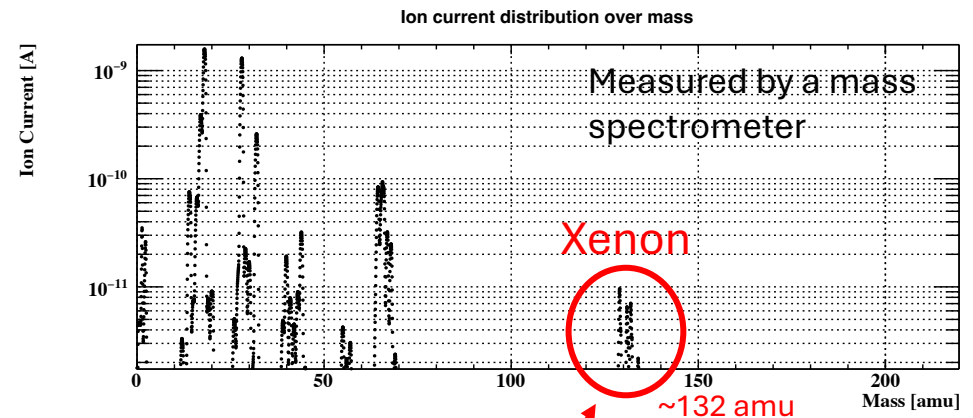
# Two Kinds of Leak: "Large" and "Small Leaks"

- Parts of the LXe detector related to leak
  - Inner vessel: LXe and GXe inside
  - Outer vessel: Evacuated continuously
  - Gate valve: Separate atmosphere and GXe
- **"Large leak"**
  - From inner vessel to atmosphere via gate valve
    - Happened only in 2024
    - Lost 40-80 kg xenon until the middle of September 2024
  - Cause: lack of leak tightness of the gate valve
  - **No leak anymore**
    - Dealed with temporarily
    - Need exchange of the gate valve
- **"Small leak"**
  - From inner vessel to insulation layer
    - Happened from 2021 MEG II run
    - Lost 10-20 kg xenon until the middle of September 2024
  - Cause: Lack of leak tightness of inner vessel gasket

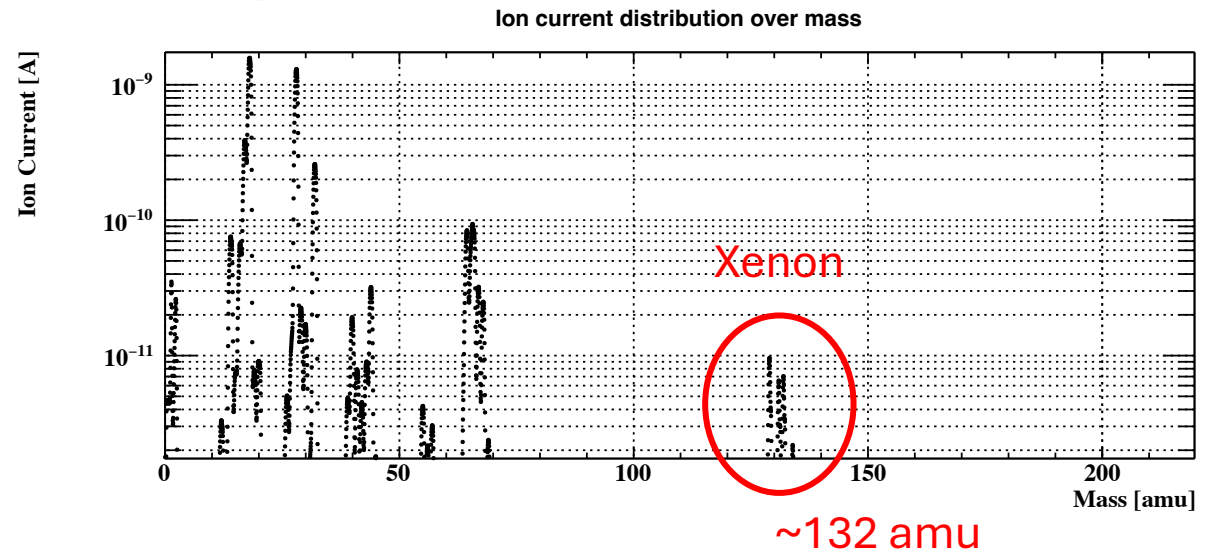
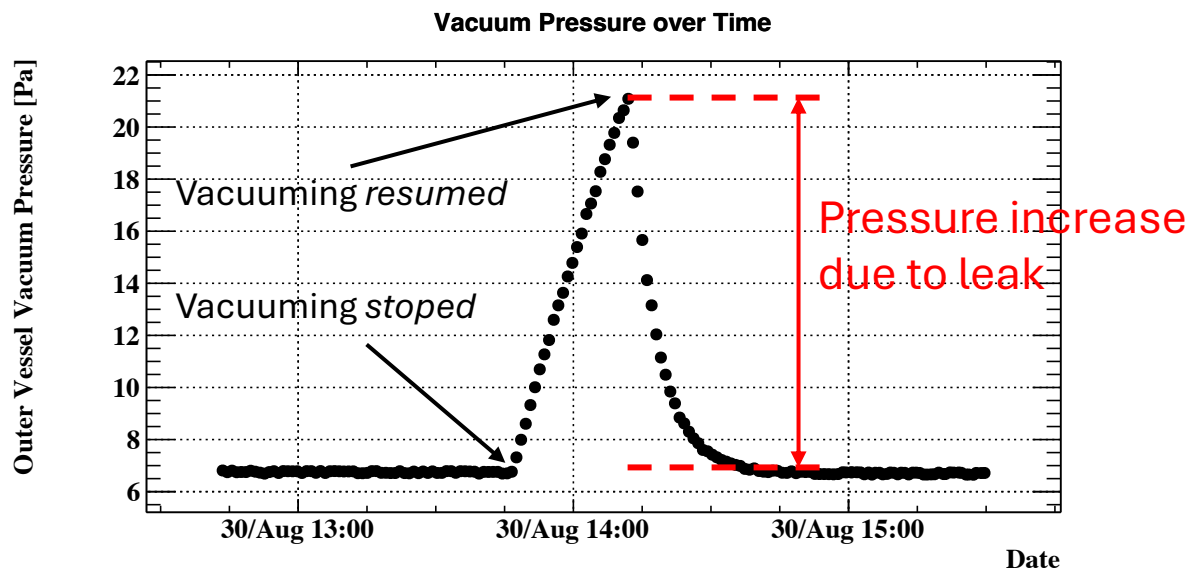
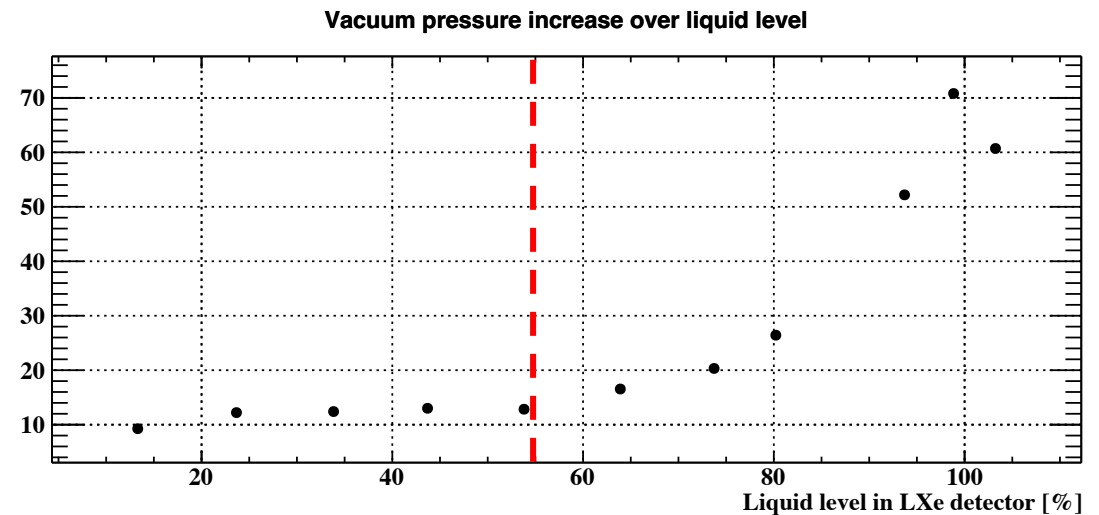
# Pressure Increase of Insulation Layer

- Xenon was found in insulation layer
- Vacuum pressure increase rate [Pa/h] increase after 50% liquid level in LXe detector
  - Leak might be located higher than the height of 50% liquid level

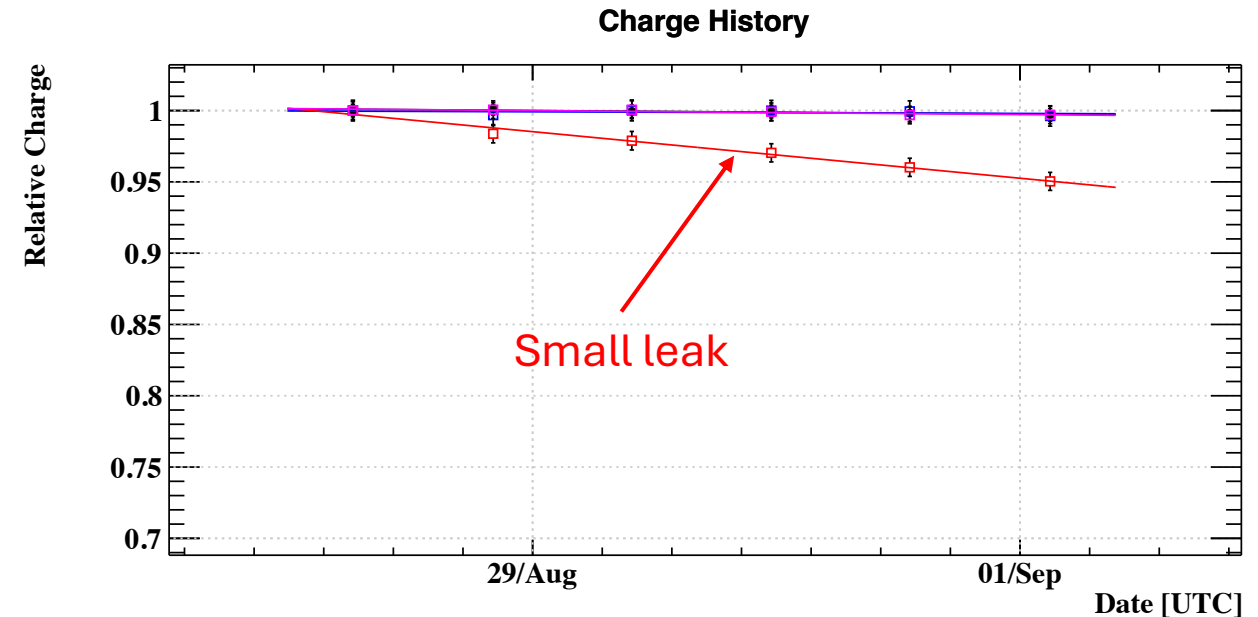
# Regularly Monitor to Detect “Large” and “Small Leaks”

- Introduced regularly monitor to detect large and small leaks

- Take data which were PMT response when LED light blinking (called “LED data”)
  - Once per day
- Regularly monitor of large and small leaks after taking LED data

- Algorithm of large leak detection

- Subtract charges of PMT which taken once per day
- If the difference is larger than a given threshold (which was determined referring previous large leak), the alarm rings

- Algorithm of small leak detection

- Calculate the slope of PMT charges, which taken once per day, for the past 7 days
- If the slope is larger than a given threshold (which was determined referring previous small leak), the alarm rings
