04/Aug/2005

19:55 RUN # 9368 pedestal. @ no data written
RUN # 9369. Gain adjustment RUN. no data written

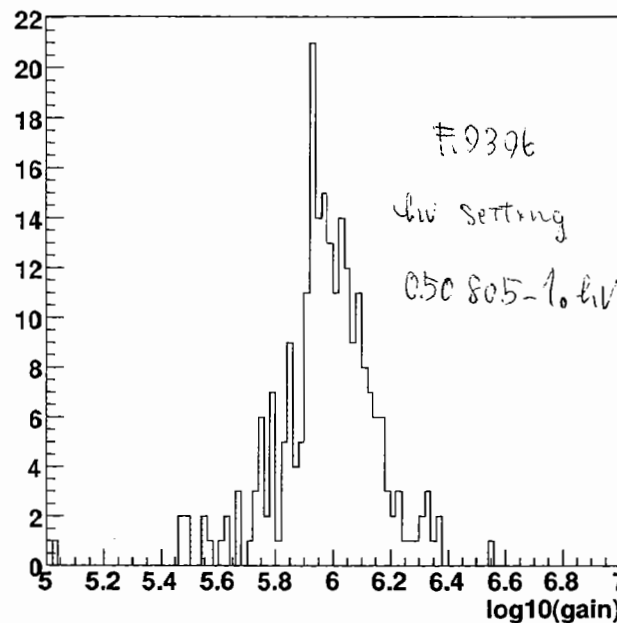
There are some channels that could not be calibrated, but the gain distribution is sharper than that of #9396
See the next page.

Since the gain distribution with 050805-2. hv was rather wide, a new hv setting file was generated by taking average between two settings, 050805-1. hv and 050805-2. hv

This is saved as 050805-3. hv and now loaded.

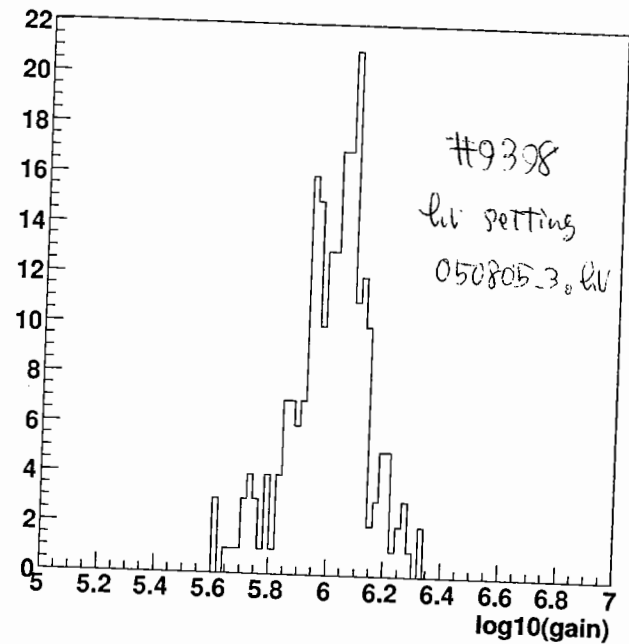
gain distribution

This means that HV and gain relation implemented in the LPTFRAME work may be obsolete. That relation is for R641 and we should optimise it again for the final design TMT.

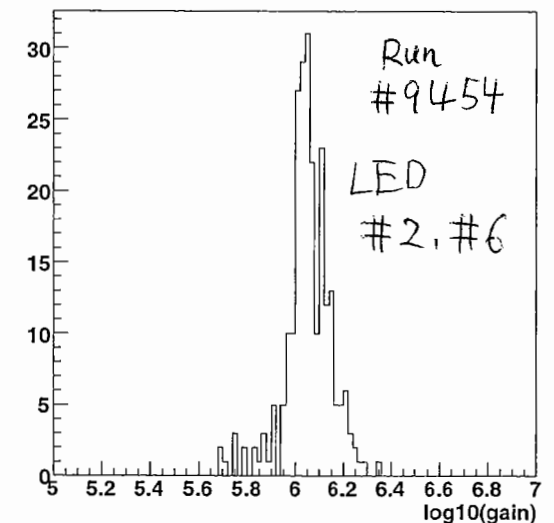
gain distribution

I found LED (#2, #6) data was rather good because the ADC mean vs σ^2 distribution was fitted well.

So I want to try HV adjust run again by using LED (#2, #6).

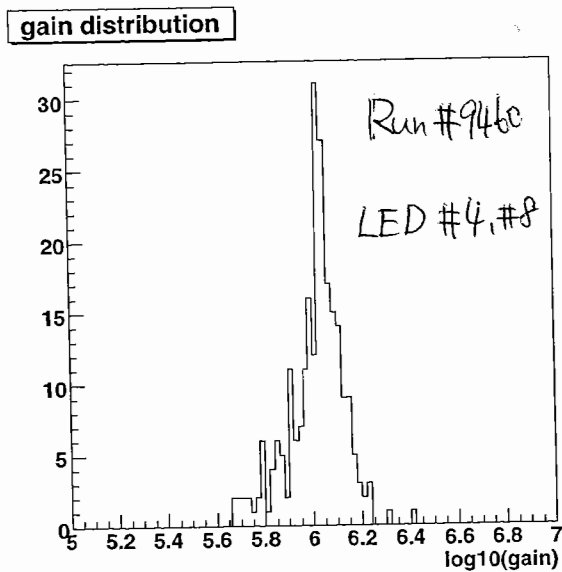
(#4, #8) = (width 50, 78.8
step 1)

(looks similar result as #2, #6)
