25 / Mar / 2002

17:55 Fix up noisy signal cables.

Cables between the chamber and the electronics Rack were checked. Check was done by putting a 50Ω Terminator at the G10 connectors and measuring the Resistance at the patch panel for the delay cables.

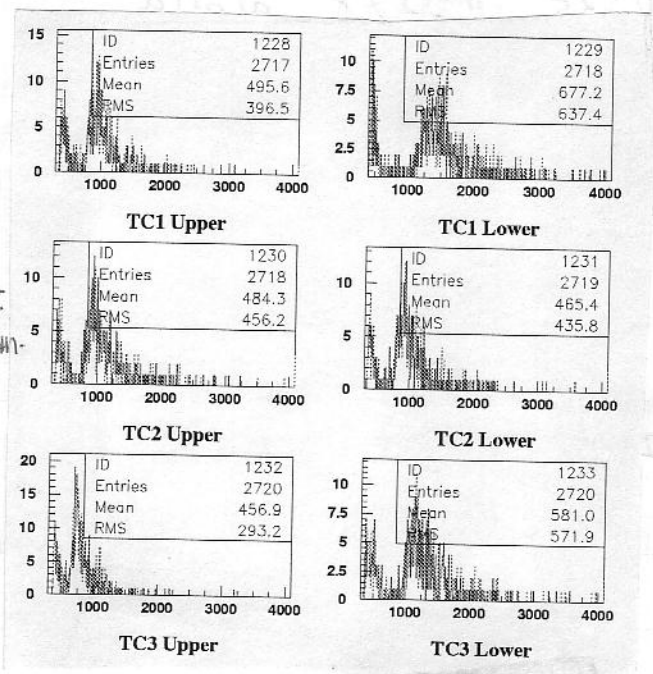
ADC spectrum.

Same as before @ TELAS.

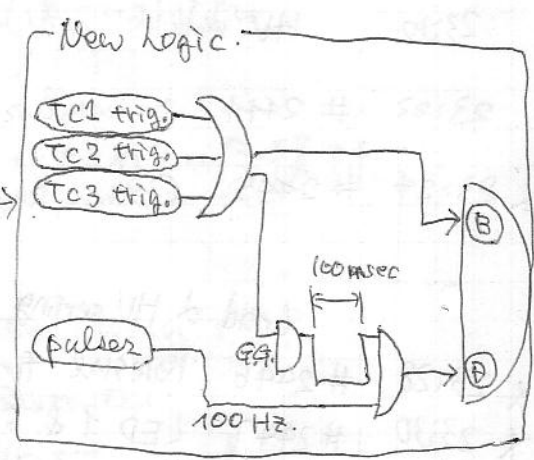
16:10. #2434. Cosmic ray run @ 1e6. with pedestal.

(B) trigger is opened by Cosmic ray event.

(D) trigger is pedestal x 10 after cosmic ray event.

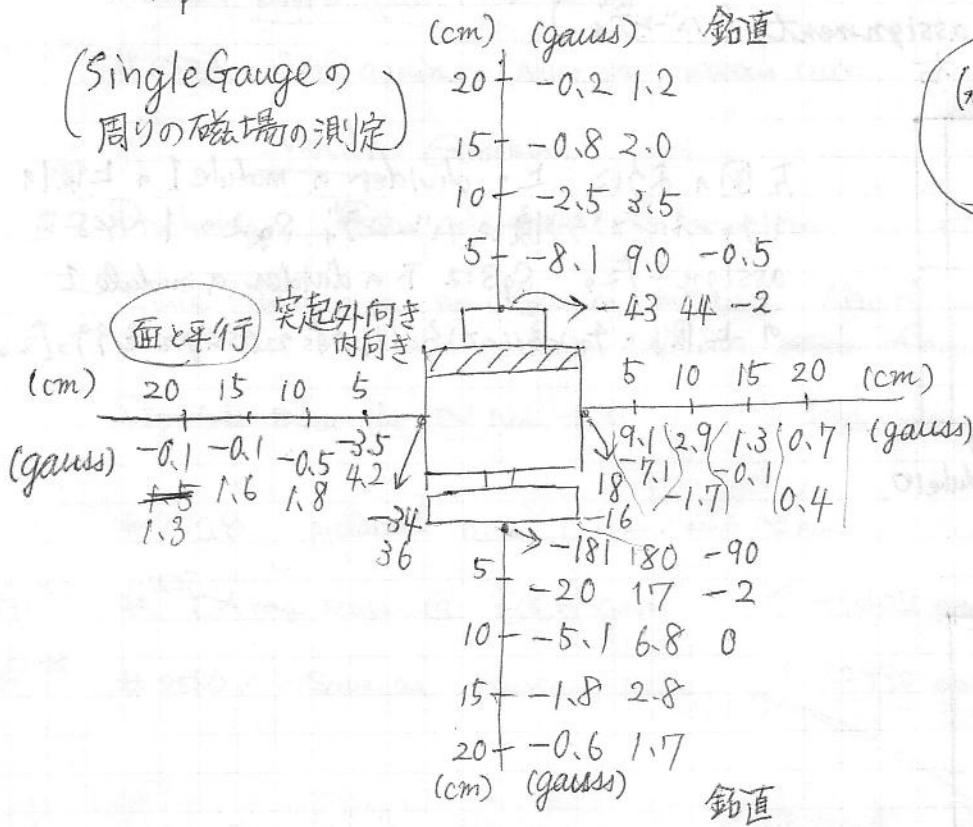
(Single Gaugeの周りの磁場の測定)

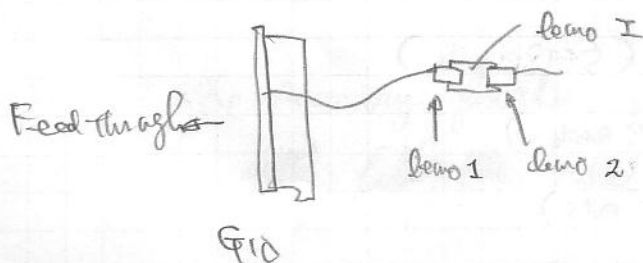
Sig 2-14. This had a problem and previously fixed by inserting lemo connection near the G10 board

The Lemo 2 connection as shown in the left figure is CRAMPED Again → OK

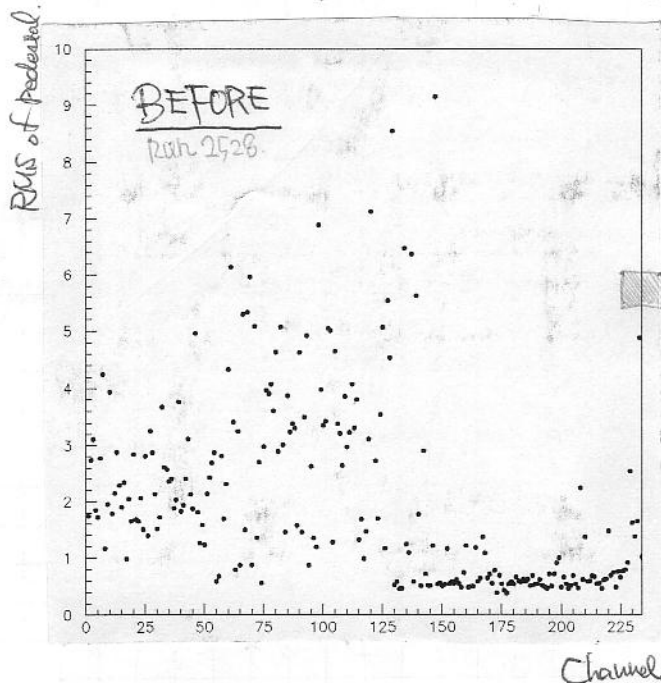
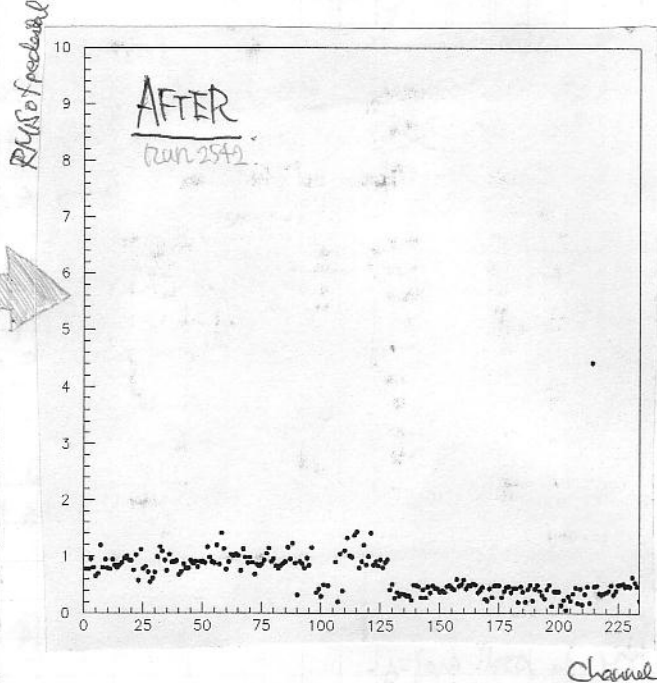
The RMS of pedestal distribution (@ All channels, individual)

- * The RMS of pedestal get excellent improvement !!
- * The RMS @ all channels are < 2 ch.

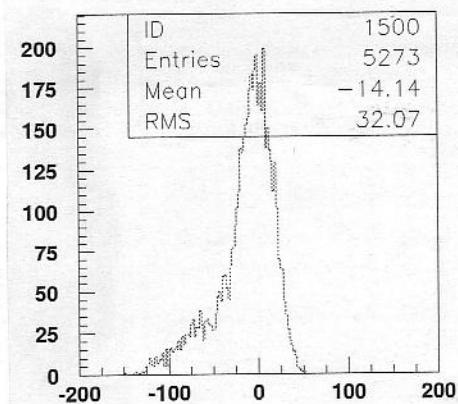
Even sum

* The pedestal sum distribution has 2 components?
Was it occurred by divider ???

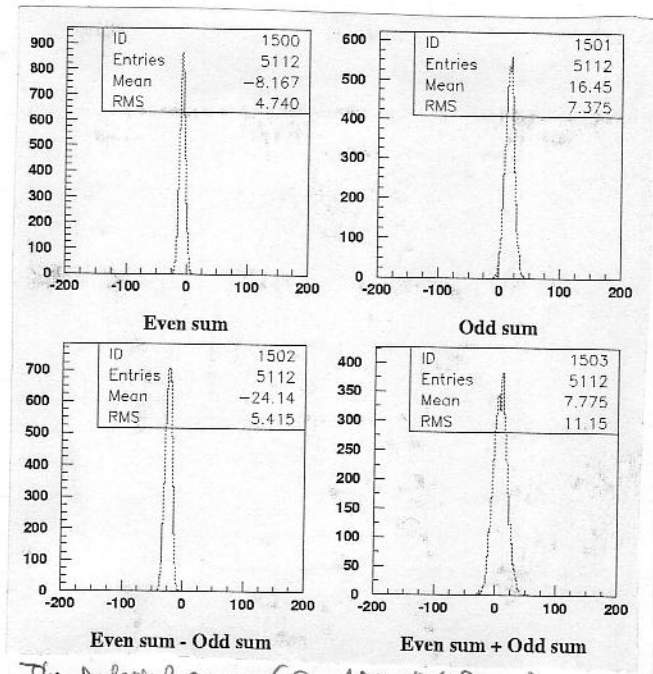
* Fine check the active divider effect for coherent noise.

The Pedestal Sum (@ ADC #1 ~ #127) with ACTIVE DIVIDER.

The Pedestal sum (@ ADC #128 ~) w/o ACTIVE DIVIDER.

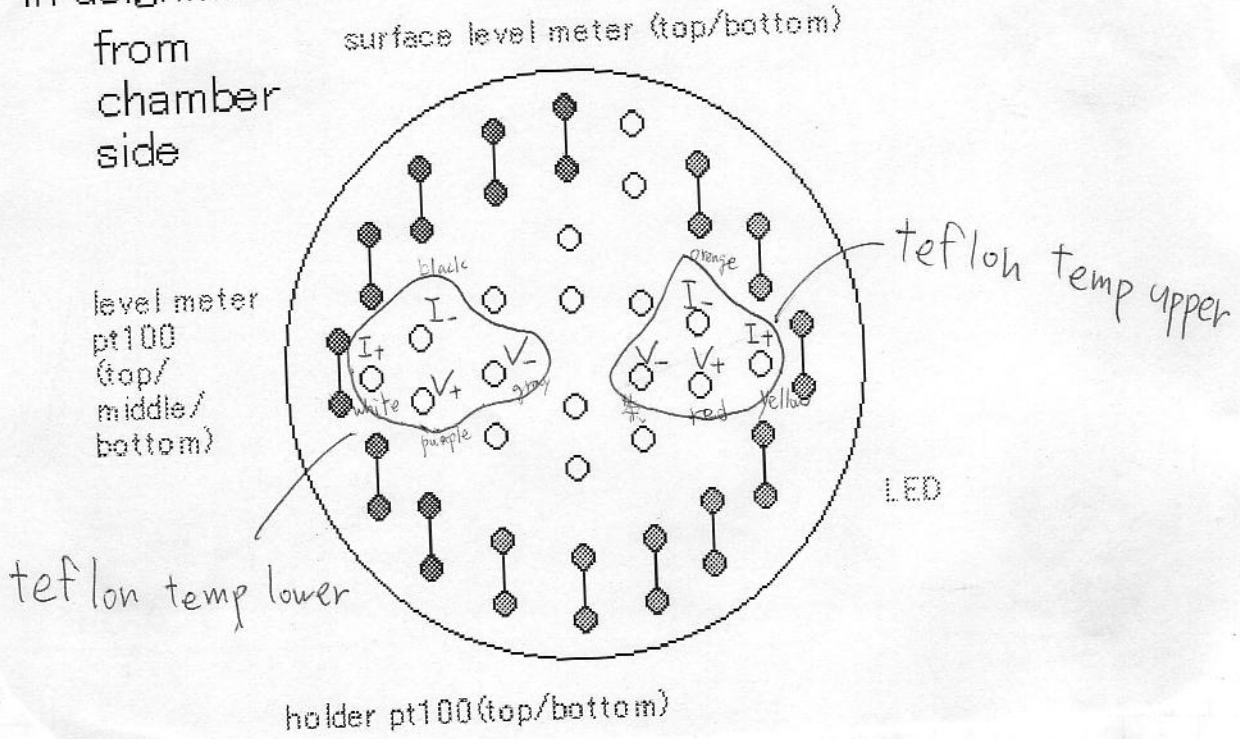
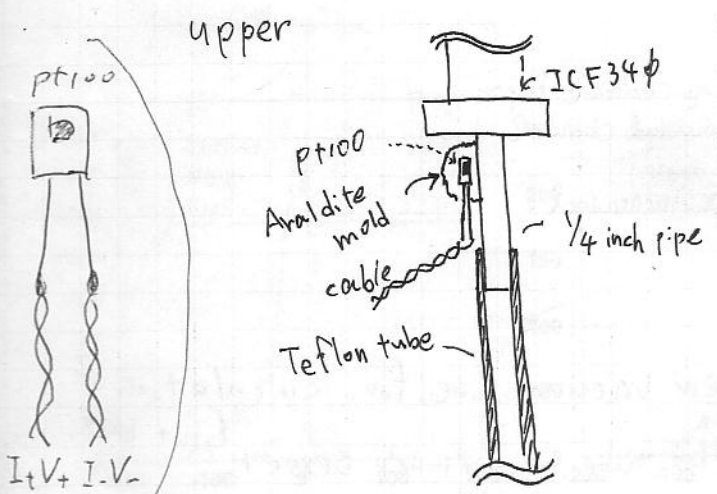
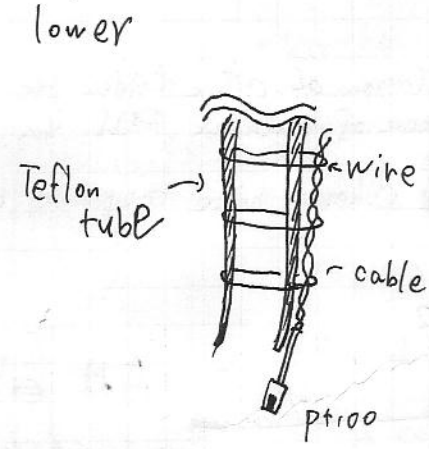
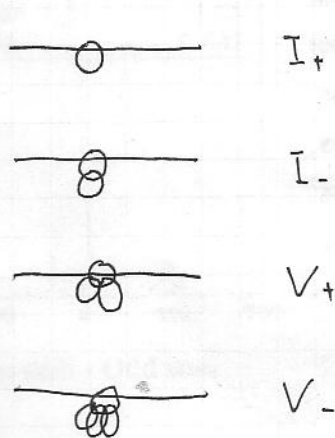
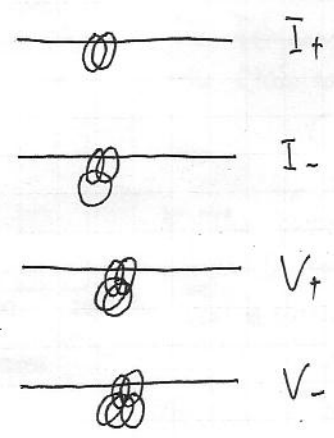
Pin assignment of the sensor cables

new pt100s set up
